## **Beycesultan Excavations: Second Preliminary Report, 1955**

Seton Lloyd; James Mellaart

*Anatolian Studies*, Vol. 6, Special Number in Honour and in Memory of Professor John Garstang.  
(1956), pp. 101-135.

### SECOND PRELIMINARY REPORT, 1955

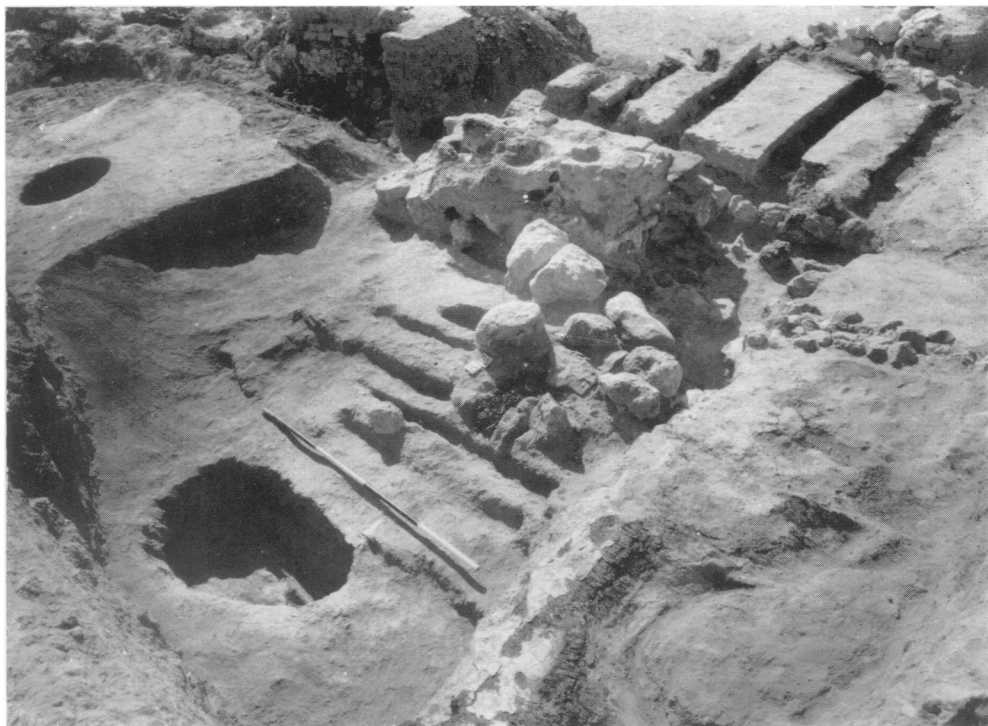
(a) Portico of Room EV/20, with Cavity left by a Wooden Column-stump.

The elaborate construction necessitated by the tangle of sub-pavement heating passages at this point can clearly be seen in our perspective reconstruction (Fig. 5). The partial collapse of one of the stone piers and the subsidence of the floor in the portico itself had created great confusion ; but two circumstances made the present reconstruction possible and convincing. First, where the twin heating passages pass between the two piers, the suspended floor remained intact, supported on burnt debris beneath, and the impression in it of the wooden joists (with the carbonised remains of the joists themselves), were perfectly preserved (see Pl. VIIIa).

Secondly the stump had survived of one of the two wooden columns shown in our figure. It had somehow escaped the fire and the shrunken and dehydrated remnants of the wood itself lay at the bottom of a cavity in the ground, faithfully recording the exact size and shape of the original (Pl. VIIIa). The small floor-joists between column and pier seemed to extend further than was strictly necessary to span the heating passage, perhaps in order to form a step leading down into the hall. Above them an interesting feature was a bed of rushes, laid over the pavement to a depth of more than 4 inches, perhaps to dry one's feet on entering the reception-hall. They were held in place by a curb of small stones on a line with the pier.

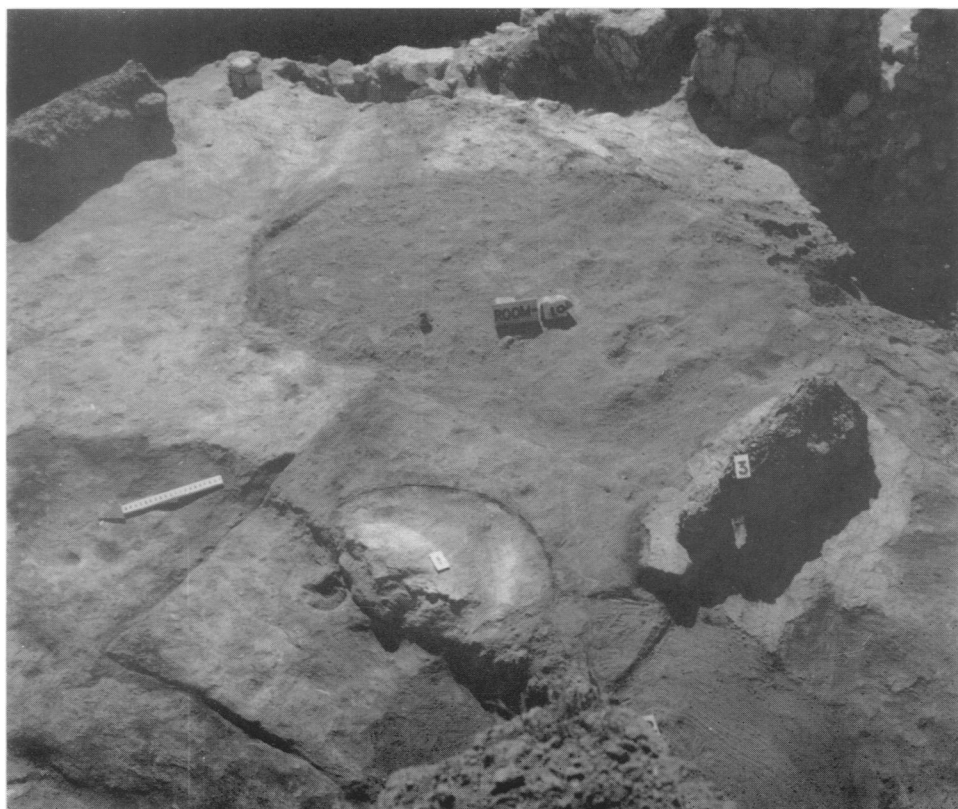
(b) Column-base and Burnt Fragment of Column in Room EV/10.

The single column-base found in this chamber can be seen in Pl. VIIIb. It is built up in mud brick to a height of 15 cm. above the clay pavement and plastered. The circular wooden column apparently stood directly upon it. The east wall of this chamber had unfortunately been brought down by the collapse of the terrace-wall upon which it stood ; but the remains of very large beams lying on the adjoining pavement gave the impression that direct lighting had been obtained on this side through wide openings. In fact some unusual architectural treatment would be necessary to explain the position of the column, set back from the centre of the room. On the south side of the chamber the ends of the joists spanning the heating passages could still be seen embedded in the floor. Here also sufficient plaster remained on the wall to show that this room also had painted ornament, though the colours were too much affected by the fire to be identifiable.

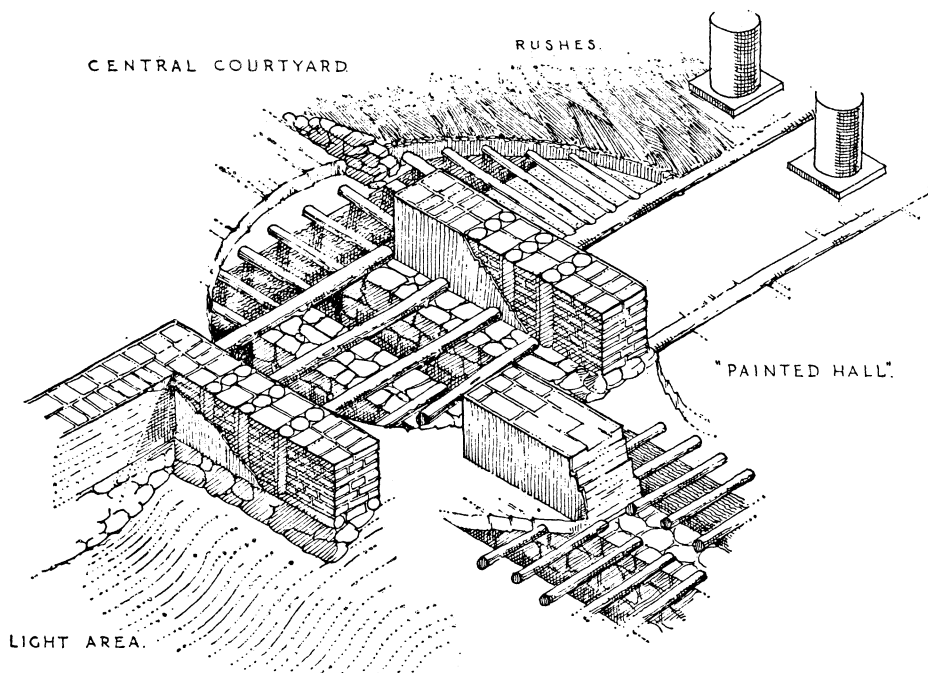
FIG. 5. Perspective restoration of Portico to Room EV/20.

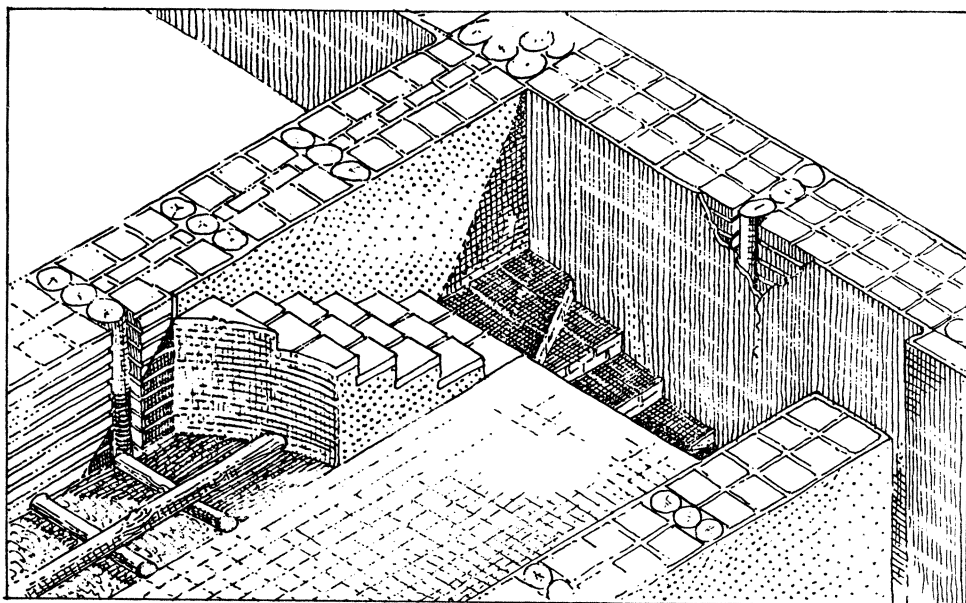
FIG. 6. Perspective Restoration of Stairway in Room EV/9.

The two storage-chambers EV/4 and 14 were paved with cobbles at basic pavement level. Through them access was obtained to the staircase chamber EV/9. This room had a smooth clay pavement, level with that in the Painted Loggia, and a brick stairway, starting at its northern end from basic pavement-level, ascended along its western side towards an upper story. As will be seen in our perspective restoration of this room (Fig. 6), the weight of the stairway was supported at upper pavement level on a framework of wooden beams. A third flight must have been suspended on beams over the little compartment between Rooms EV/9 and EV/2.

At this point the fire had burnt with unusual ferocity and the remains were extremely difficult to understand, but it was possible to be certain that in this compartment there had also been a minor stair, bringing one down to the low-level pavement of Room EV/2. It was built of stone, now completely calcined into white powder, around two brick newell-posts. Judging from the mass of brickwork on its west side and from the wooden elements embedded in it this stair must itself also have been accessible from the top of the masonry structure, in which the metal cisterns were set, between the two parts of the light-well, EV/1 and EV/3. Perhaps this enabled them to be filled from above.

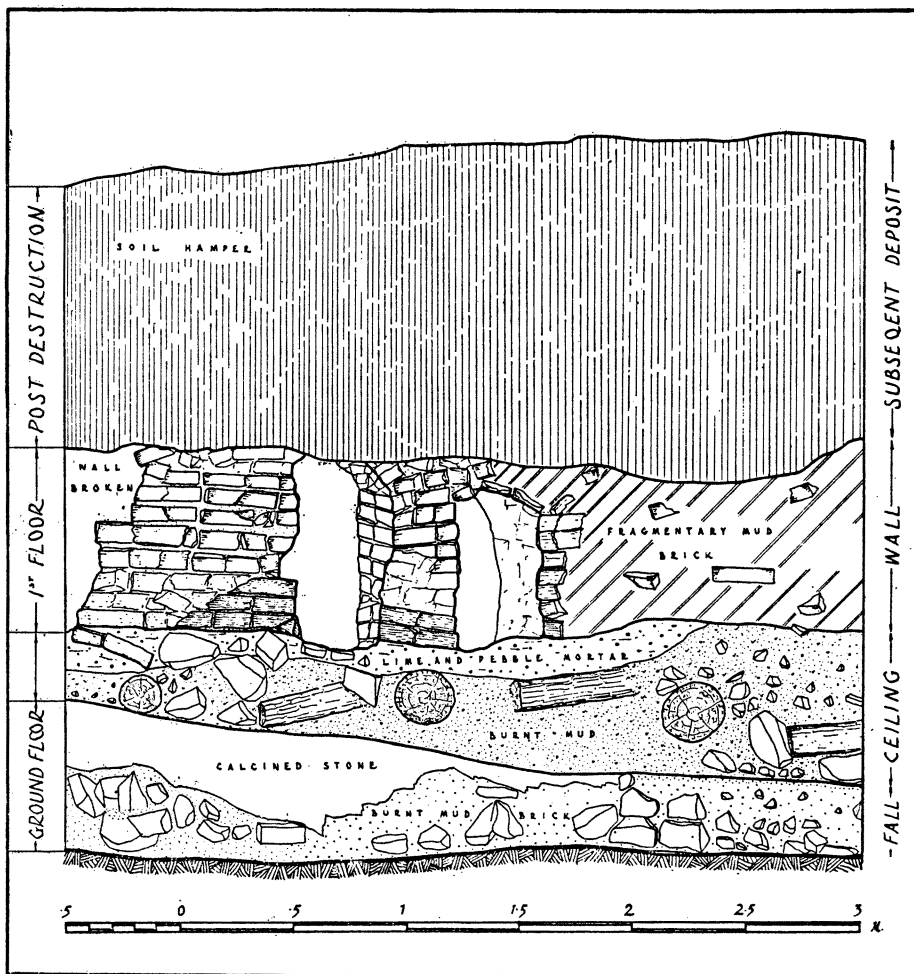
FIG. 7. Field Drawing, showing remains of West Wall in Room EV/7.

shaped stone tread remained intact. This room had a cobbled floor, liberally strewn with carbonised beams, fallen from the ceiling or roof. The east wall was unusually well-preserved, its substructure having only partly collapsed (the system of wood reinforcement was best illustrated here), and the brickwork, with the gaps from which its posts had fallen, remained standing as much as M. 2.00 high. The west wall presented a much more complicated problem. The stone foundations had in this case completely subsided, the fire seeming to have levelled its calcined remains to a uniform surface. Above this was the remains of a wall, again consisting of alternating piers and post-holes, but separated from the stone beneath by a thick layer of compressed earth in which were embedded the burnt ends of wooden beams 20 cm. or more in diameter, strong enough in fact to have supported an upper floor. It was difficult not to conclude that the brickwork belonged to an upper story and the stonework derived from the piers of an open arcade facing on to the small courtyard EV/13. This is best illustrated by our field-drawing of the remains of this wall as found (Fig. 7).

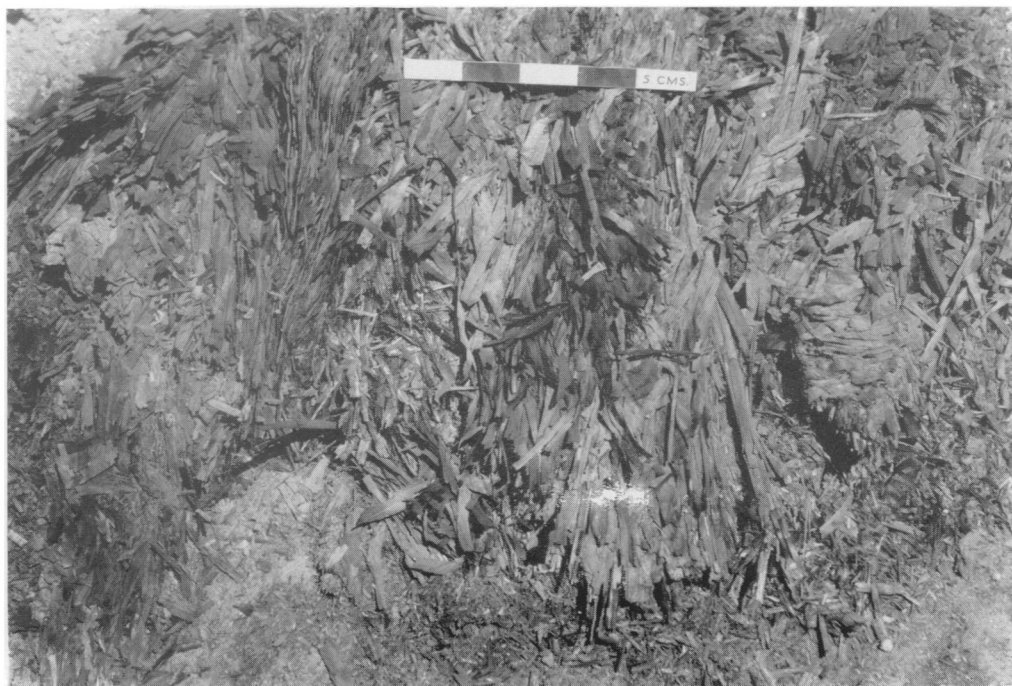
(b) The Pavement of a Chamber in the Palace bedded in Rushes.

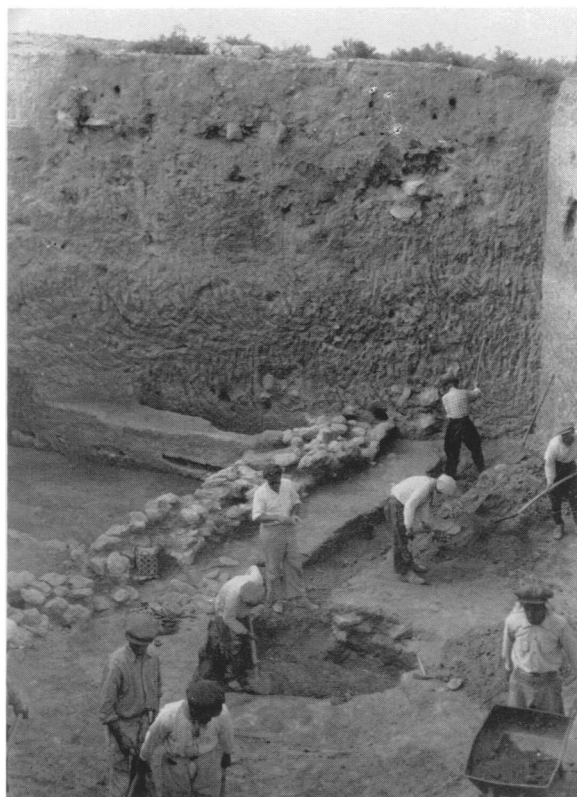
(a) Walls of a Public Building appearing at Level V in Sounding "A".

situation of Level V, in which the Burnt Palace was discovered. One of these covered an area of M. 18.00  $\times$  M. 26.00, corresponding to the western half of our "A" excavation of the previous year. In 1954 this area had been carried down as far as Level III, where part of a simple stone building had been exposed. This was now removed and beneath it we found Level IV, as usual represented by a heavy deposit of stratified occupational debris, over M. 2.00 deep, in which a single building level was indicated by one dilapidated stone wall. When Level V was reached, however, it proved to be easily recognisable, since here once more, cutting diagonally across our sounding, were walls nearly M. 1.00 thick, plentifully

reinforced with timber (see Pl. Xa). Parts of two chambers fell within the area of the excavation, separated by a mud-brick partition-wall, whose foundations consisted of longitudinal beams laid on a bedding of stone at pavement level. At right-angles to this ran the outer wall of the building, a much stouter affair, built of stone. Founded nearly M. 1.00 beneath the pavement, the surviving structure showed no less than four superimposed tiers of timber framing, consisting of runners and cross-ties. Ceramic evidence provided any confirmation necessary that this building, whose size and importance is already evident, must be contemporary with the Burnt Palace.

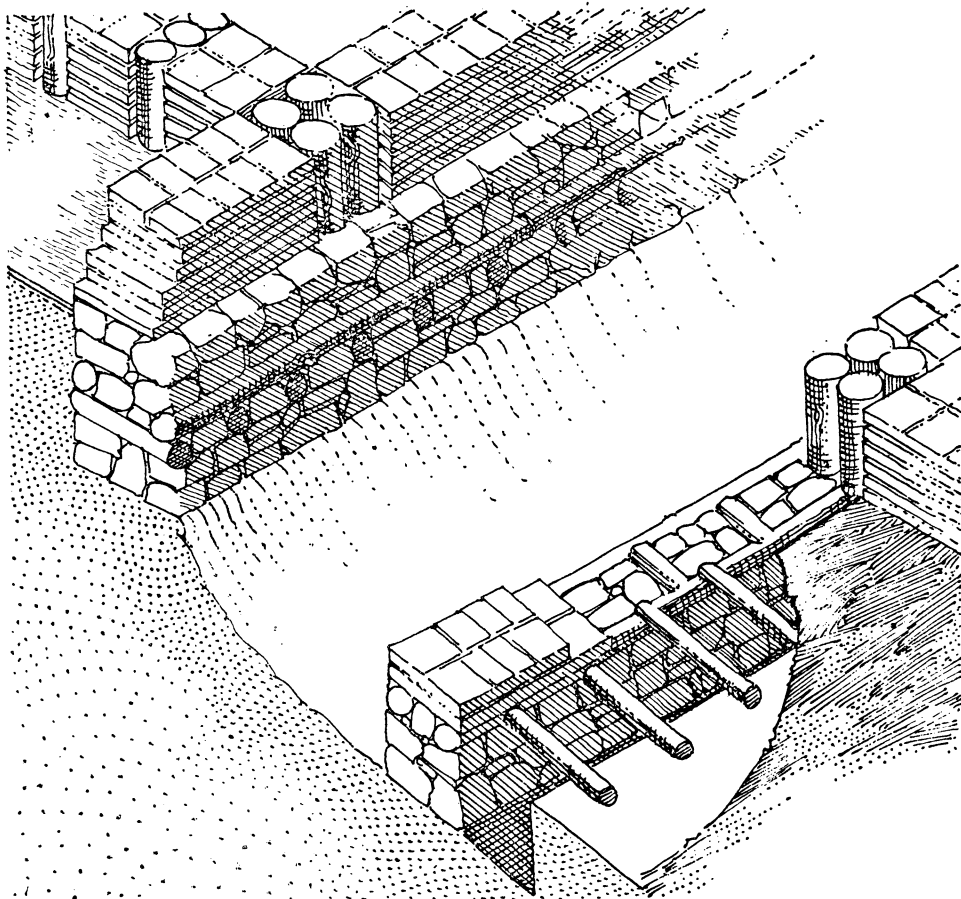
FIG. 8. Perspective Restoration showing Light-well and Wall-construction in Trench "K".

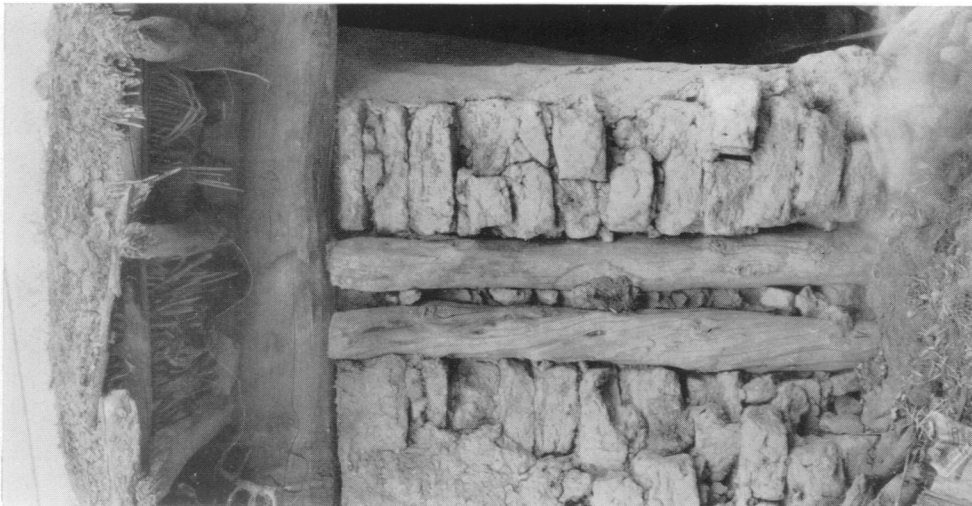
(a) Brick and Timber construction in the modern village of Mentes.

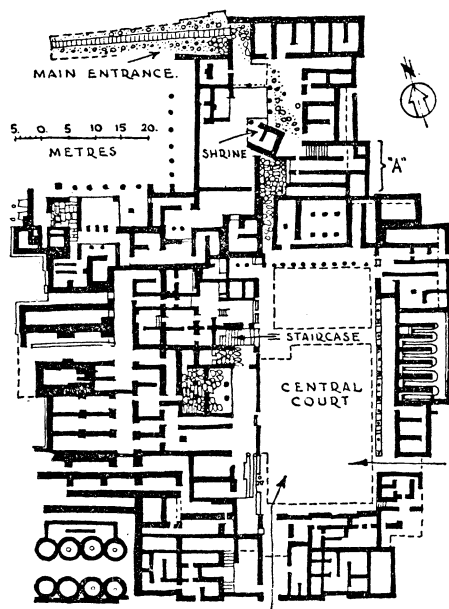
FIG. 9. Sketch-plan of the Palace at Mallia, in Crete.

The only ceremonial entrance so far discovered at Beycesultan exactly resembles that at Mallia, in that access is obtained, almost surreptitiously, through a recess in the outer façade and at right-angles to it. There are other points of close similarity. In both cases it is approached by a steep ramp or causeway: it leads through an outer vestibule into a "lustral area" for ablutions (at Mallia the paved peristyle court) and in both cases brings one eventually to a pillared hall, reached through a colonnade or columned portico. At Beycesultan there are reasons for thinking that only the "Painted Loggia" was reached directly from the Lustral Room and that, since Room EV/19 was merely a service-chamber, the approach to the "Painted Hall" from the east was by way of Rooms EV/17 and 18. But a group of rooms next to the service-chamber, comprising long storage-chambers and a staircase (Rooms EV/14, 4, 9 and 2) also has a most striking parallel in an identical position at Mallia. (Unit marked "A" in Fig. 9.)
