BEYCESULTAN, 1959

SIXTH PRELIMINARY REPORT

By SETON LLOYD

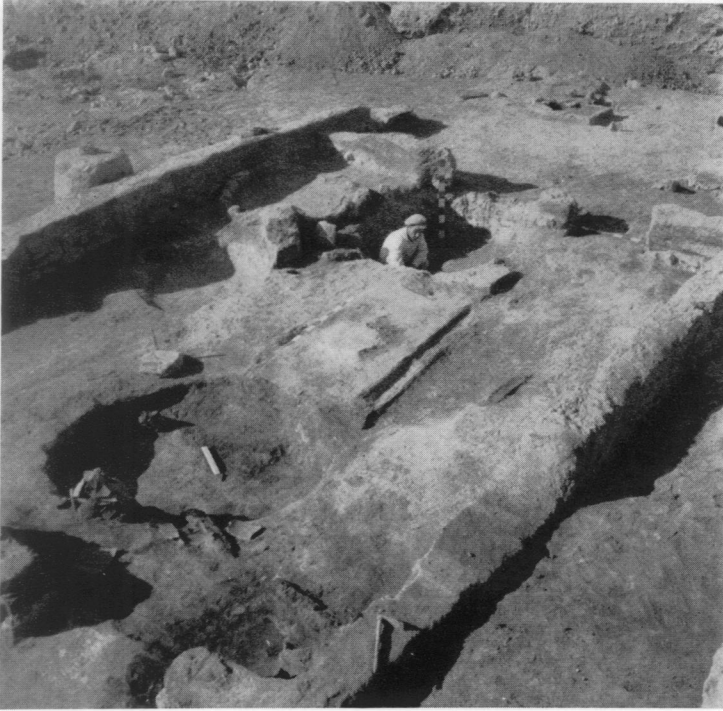
(a) Private house in Level IVb occupying a single chamber in the ruins of the Burnt Palace.

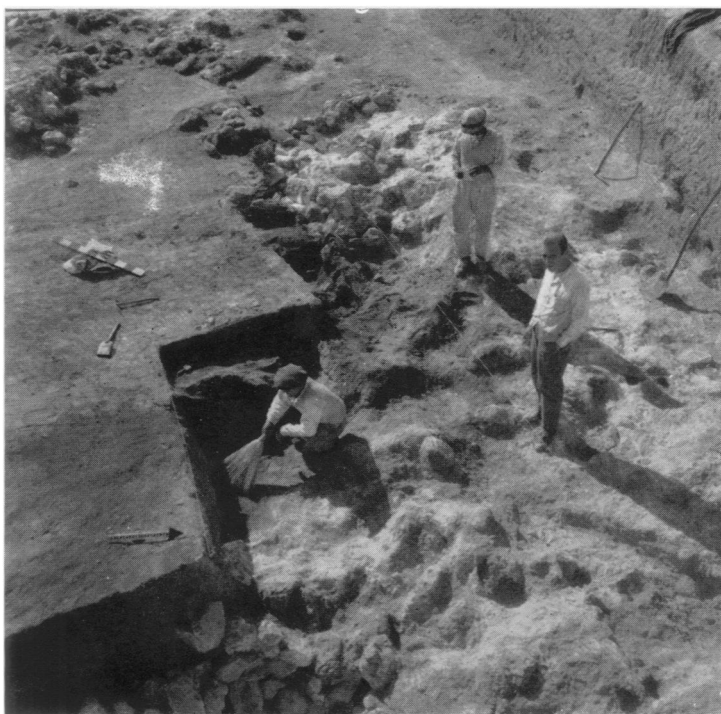
(a) Structure in the corner of Room 24.

the eastern corner of a solid structure which was almost certainly a small staircase (Plate II*a*). Room 25 may have had an entry from outside the building, though the outer wall was too denuded to be certain. Room 26, though one side of it was open to the central court, nevertheless seemed inexplicably to be provided with "heating passages" around the other three sides. Room 23 was at first a puzzle since it appeared to be a solid mass of fallen stonework: but this was eventually identified as the remains of an imposing staircase rising up in two flights from the central courtyard. And here the excavation extended far enough westward for us to learn something of the actual appearance of the courtyard itself. In

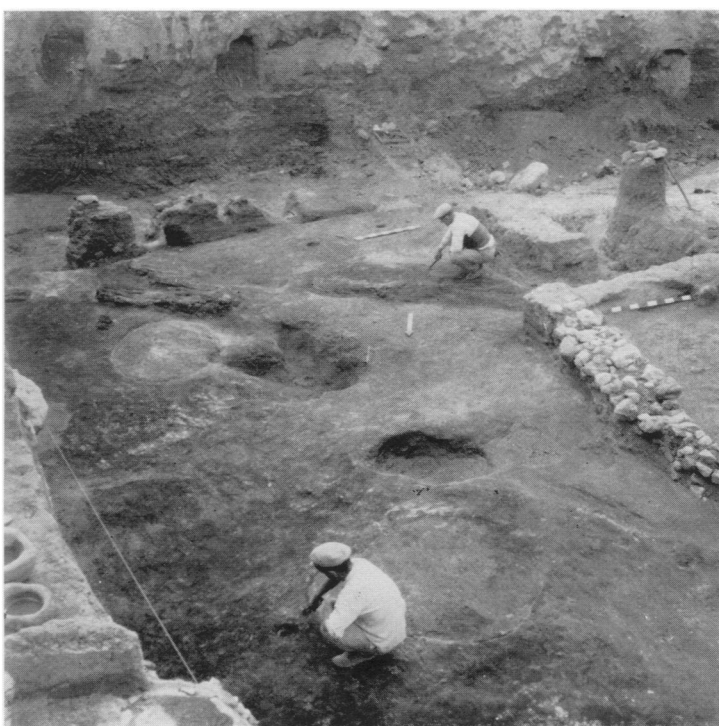
(b) Fallen upper floor lying over the ruins of the reception hall (Room 28).

(Fig. 2) and they took the form of an area about 10 m. square entirely covered by an undulating mud pavement, once more covered with a deposit of carbonised reeds (Plate II*b*). It took some days to convince ourselves that what we were dealing with was the floor of an enormous upper chamber, fallen almost intact into a similar chamber below, when the wooden posts which supported it burnt through. But this was undoubtedly the case, for the walls still survived of a small hut or storehouse built directly upon it at a different angle by the squatters of Level IV, using burnt brick and stones taken from the ruins (visible in Plate II*b*). Lying near the south-west wall of the chamber, which projected through the fallen floor, were several huge scantlings of timber, up to 3 m. in length and only partly carbonised. These will be referred to in detail elsewhere.

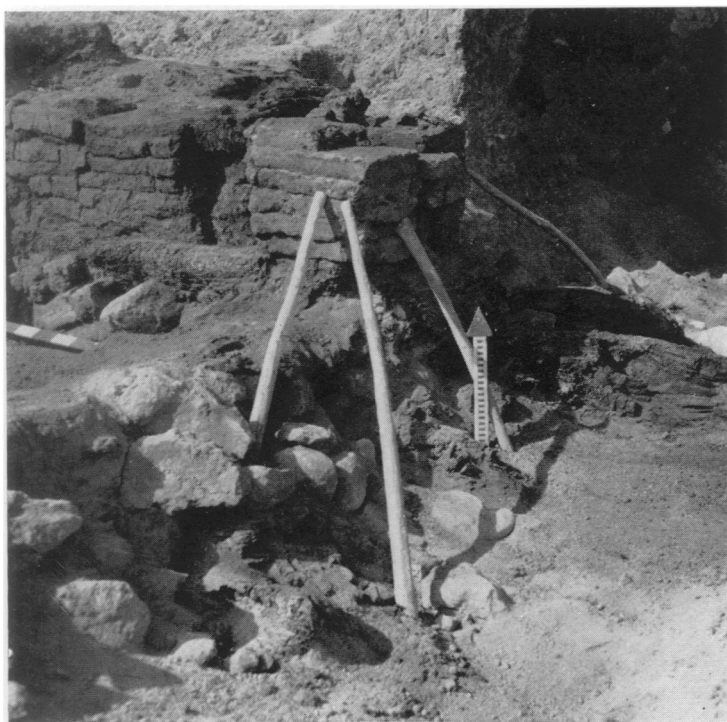
(a) Well-preserved walls of the "Portico" (Room 32) with timber framework intact.

One advantage of these fallen upper floors proved to be that, in falling, they had "blanketed" the fire beneath, and on breaking through them, we came upon a section of the building where the walls remained standing to a height of almost 2 m., the bricks hardly more than blackened by smoke and their timber framework intact, though in a carbonised condition (Plate III*a*). Thus for the first time we were able to study in detail this strange form of construction, which in the past we have so often attempted hypothetically to reconstruct. A study of these ruins in perspective, made by Miss Clare Goff, appears in Fig. 3, with a new diagrammatical reconstruction in the top right-hand corner. One sees the wall divided into "panels" of brickwork, and in the gaps between these, heavy logs laid transversely to form a base for the vertical posts, which we know to have been tied in to roof timbers above.¹ There are also "runner" beams at intervals of five or six courses in both faces of the wall itself and the ends of these also were tied in to the vertical posts and attached by cross-pieces to one another. Then comes the stone sub-structure, which also was reinforced with runner-beams at intervals, and finally the timber foundations. These wooden foundations were a feature which had not previously been observed in other parts of the building, and they now throw new light on the construction of the so-called "heating passages" which have been discussed in previous reports. One now sees how, before starting to build the wall, a foundation trench must have been dug at least three times the breadth of the wall itself. In this beams of wood were laid transversely, side by side. The wall itself was then built along the centre of the beams, leaving spaces on either side, which could either be roofed in with smaller joists to form "heating passages" or simply filled in with earth up to the pavement level on either side. The very long and heavy timbers used as foundations in the case of an important wall can be seen in Plate IV*b*, where they have been exposed by removing the burnt debris from the "heating passage". These were simply tree-trunks of juniper, their ends untrimmed after felling.

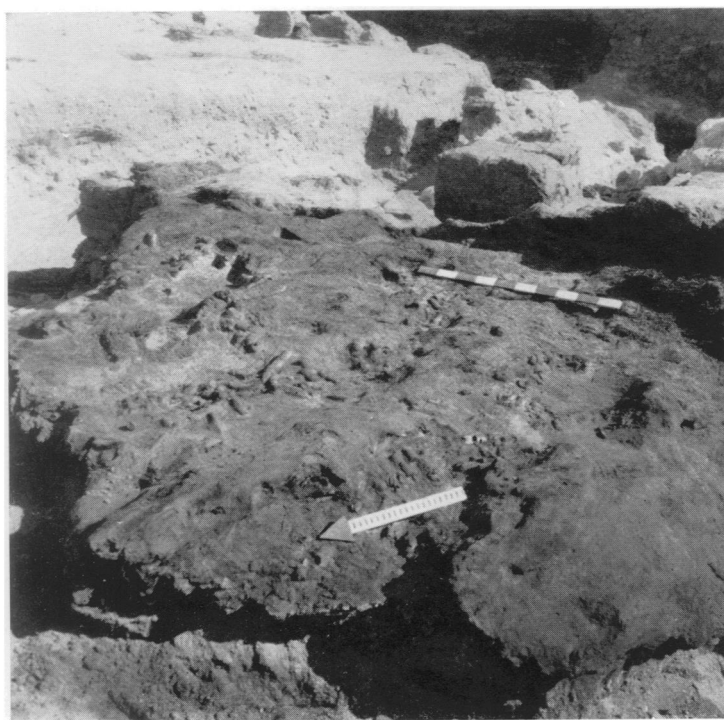
(b) Fallen upper floor in Room 33 covered with carbonised hay.

None of the rooms in the west wing had "heating passages"; but all had raised floors except Room 36 which seems likely to have been a light-area or perhaps to have contained a staircase. Each room also had the remains of a fallen upper floor, and one, Room 33, was of special interest in this respect (Plate III*b*). In this case the mud floor was deeply bedded, not in rushes but in hay, done up in bundles with cord, in which various wild grasses as well as the leaves and seed-pods of wild flowers were preserved by carbonisation and easily recognisable. (It is hoped that a specialist commentary on them may be published elsewhere.) Lying again upon these were many broken fragments of wooden rods about an inch in diameter. These one supposed to be part of the roof-structure over the upper floor.

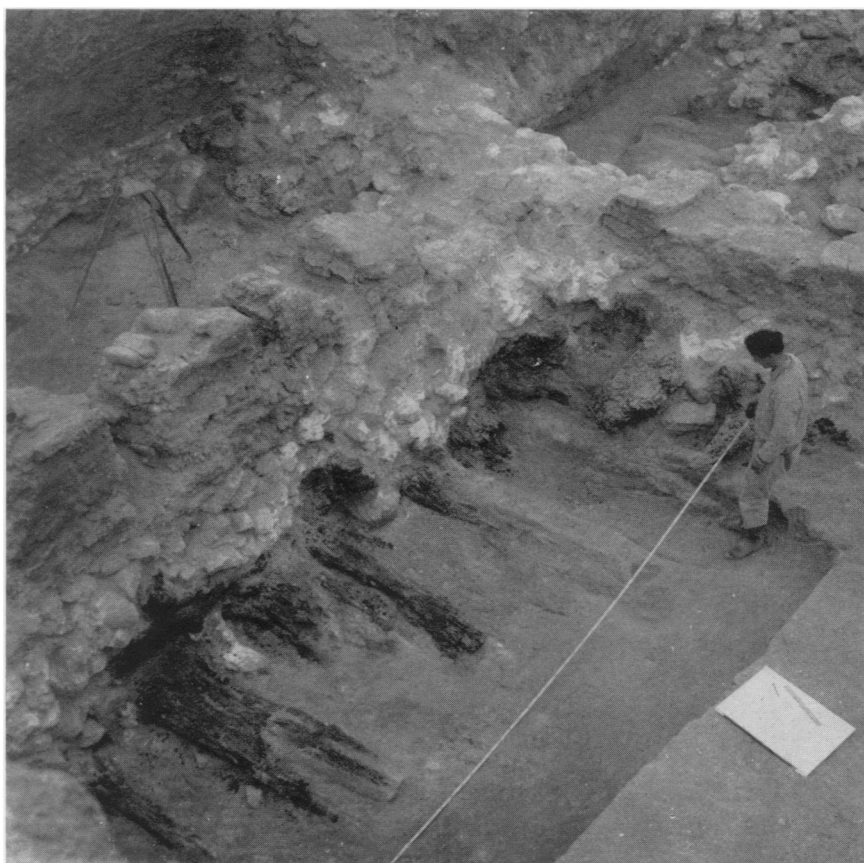
(b) Timber foundations of the south wall of reception hall (Room 28).

To the east of the portico was the great reception hall (Room 28) whose fallen upper floor had so puzzled us at the beginning of the excavation. It had an abnormally wide doorway leading south-west into a similar large chamber (Room 29), and here was another interesting architectural feature. The wooden threshold consisted of three heavy baulks of roughly dressed timber, laid longitudinally side by side on a foundation of smaller beams; and still bedded in the carbonised wood, in an appropriate position, was a hemispherical plate of bronze which must either have been the lining of a socket in which the door-pivot revolved or a "shoe" attached to the pivot itself, as has been found in Assyrian buildings. Near this doorway also lay the three large wooden fragments previously mentioned, which may have formed part of the door-lining or architrave. On the reverse side of one, when we lifted it, we found two square sockets about 30 cm. apart, still containing the remains of circular-headed wooden bosses which may perhaps have been ornamented with carving (Plate IV*a*). It has always been assumed that architectural features of this building such as wooden columns, panelling, etc., may have been enriched in this way; but this was the first, and may remain the only evidence found during the excavations to confirm the impression.
